Considerations for Determining Safe Separation Distances from Mass Fires: a Literature Search

Thomas L. Boggs
Jacobs Naval Systems Group, Ridgecrest, CA 93555

Josephine Covino
*Policy Development Division
Department of Defense Explosives Safety Board, Alexandria, VA*

2010 DDESB Seminar

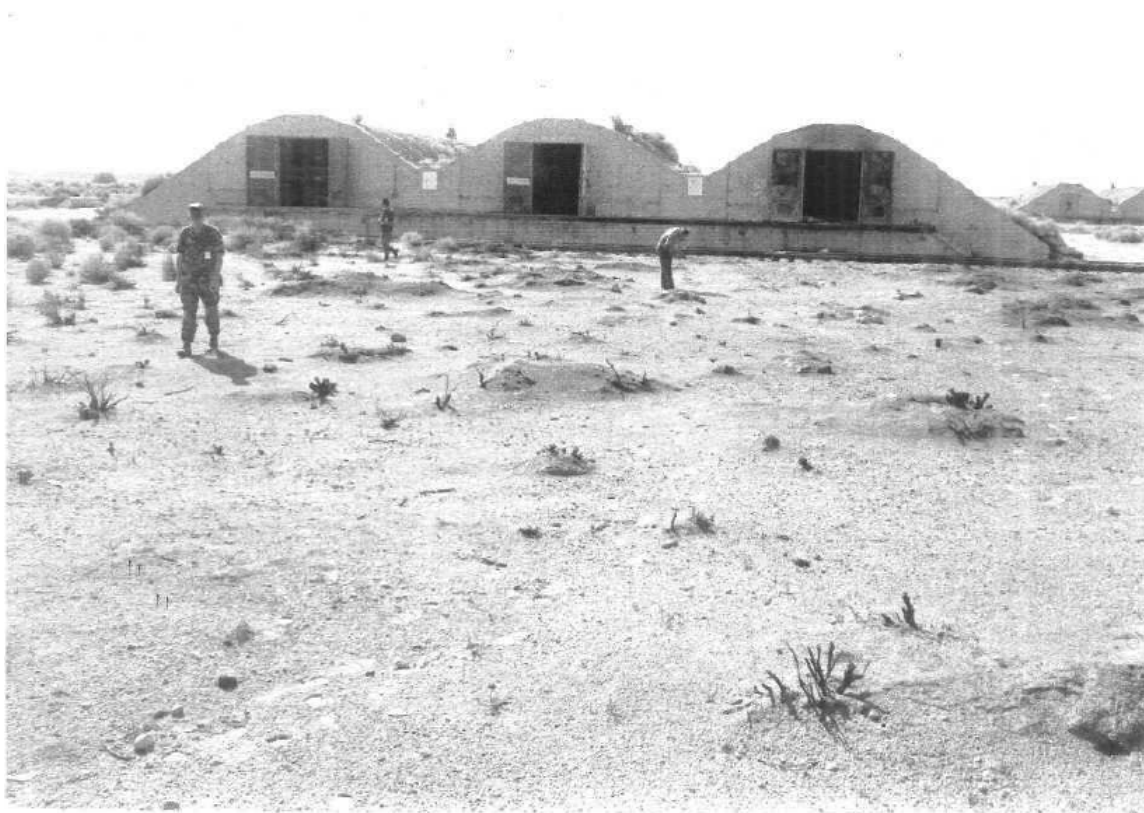
FIGURE 1. Three Arch Earth-Covered Magazine at Hawthorne Army Ammunition Plant.
Fire occurred in unit on the right.

The magazine contained 30,715 pounds of Hazard Division (HD) 1.3 Navy propelling charges. Many of the lots had low stabilizer levels, and Hawthorne had requested permission to dispose of the items by open burning. Unfortunately, the State of Nevada denied their request. Fire occurred and blew open the doors. Flames extended out 100 to 150 feet. The very intense burning continued for about 3 minutes and then decreased significantly. During the period of decreased burning, several “pops” attributed to deflagration occurred, but there was no detonation. The fire was allowed to burn itself out. Cartridge cases, unburned propellant grains, and pieces of cork were expelled through the doors and found scattered on the ground directly in front of the magazine; in addition, several cartridge cases were found several hundred feet from the magazine. The fire was attributed to stabilizer depletion in single-base propelling charges.

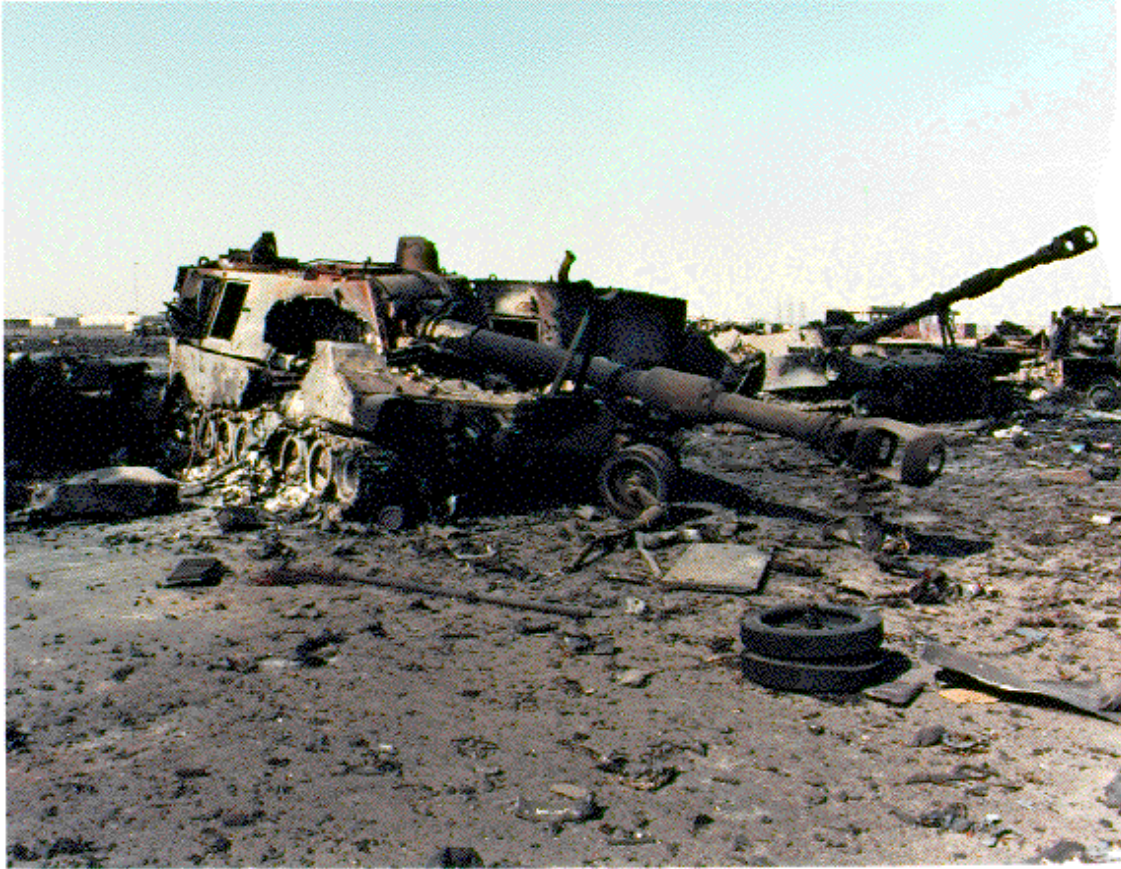
A defective heater in a M992 ammunition carrier loaded with 155 mm artillery shells caught on fire. Unit members tried unsuccessfully to fight the fire before being ordered to evacuate the area. The fire burned for approximately 40 minutes before the burning M992 exploded. This set off an hours-long series of fires and explosions that devastated vehicles and equipment and scattered unexploded ordnance and debris over much of the camp as shown in Figure 2. The fires and explosions destroyed over 102 vehicles, including four Abrams M1A1 tanks and seven M109 howitzers. There were no fatalities (although three fatalities occurred during clean-up activities), and 50 U.S. and 6 UK troops were injured.

FIGURE 2. Destroyed M109 Howitzers at Camp Doha, Kuwait.

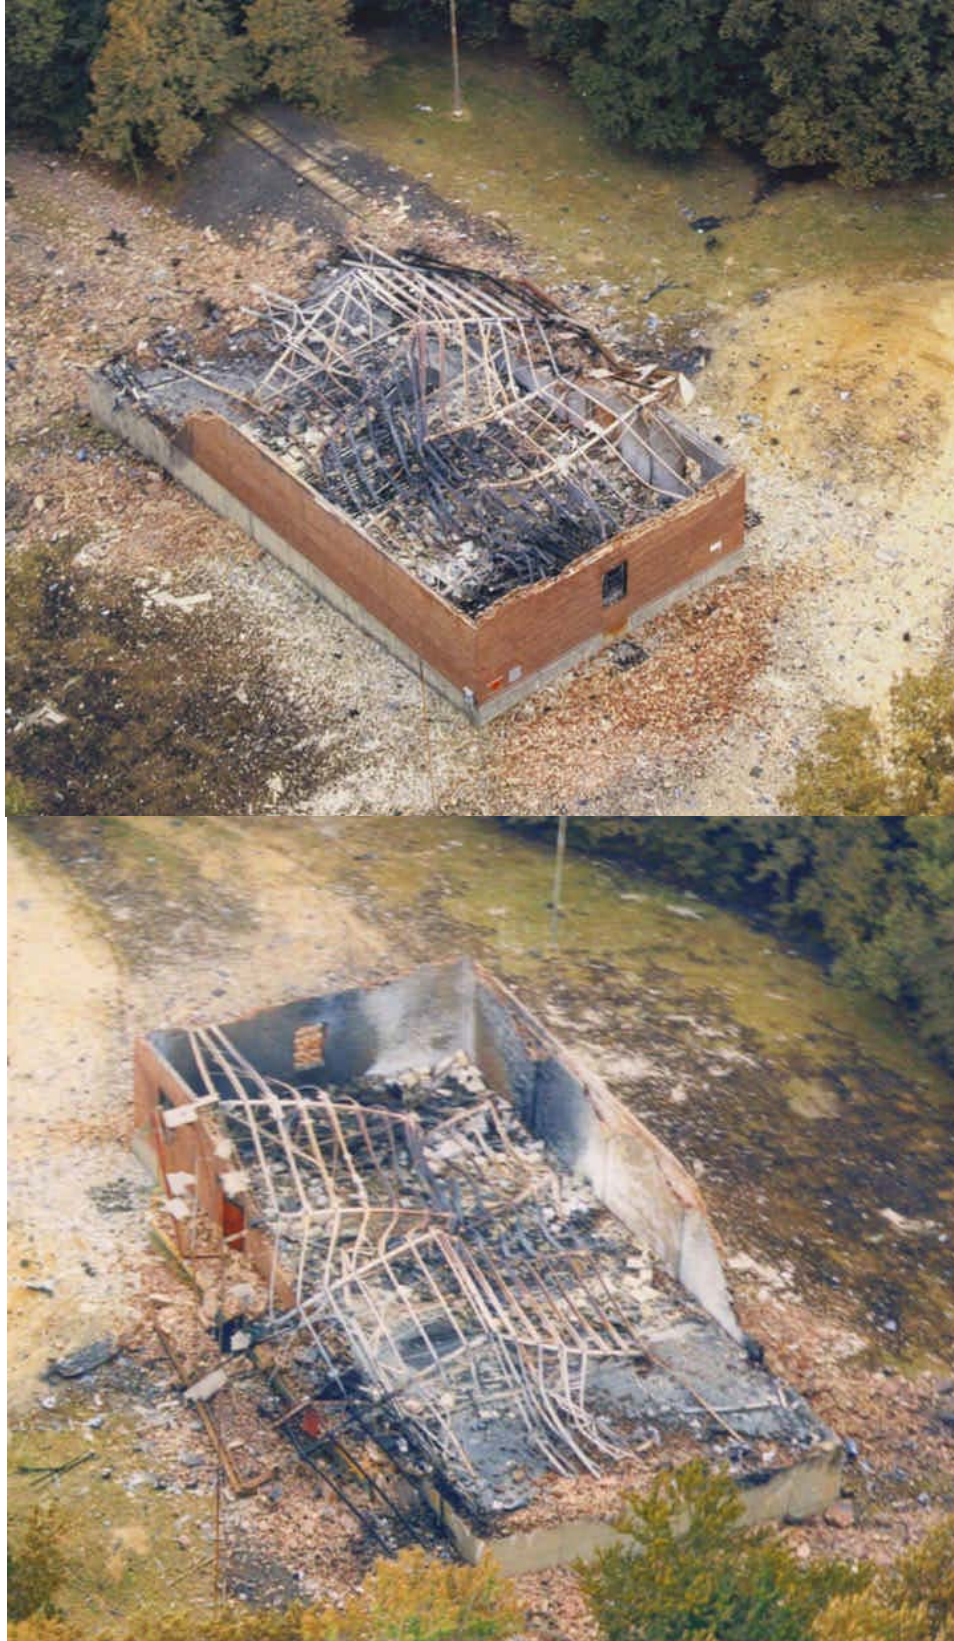
The surmised sequence of events started with auto-ignition of nitrocellulose gun propellant. The fire spread and involved a relatively large quantity of magnesium-teflon-viton flare material, which provided an intense boost to the fire. This in turn led to the first and largest detonation followed by a series of smaller detonations.

FIGURE 5. Magazine 518 after the Fires and Detonations.

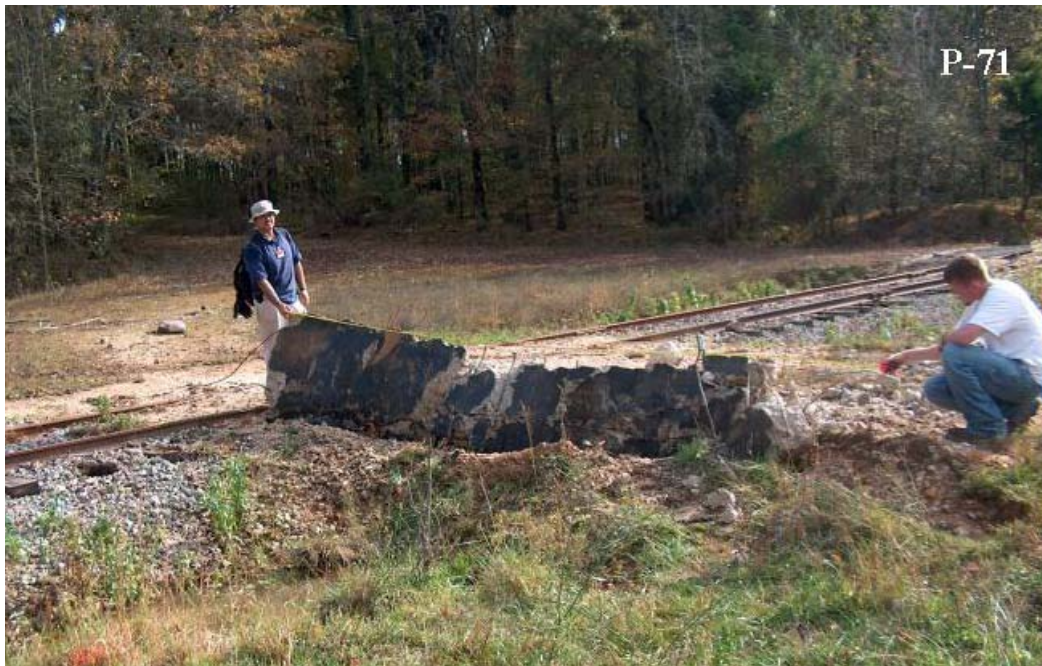
Witnesses reported hearing two blasts in rapid succession, with the second blast being more powerful than the first. Of particular interest was the size of some of the debris and the distances it was thrown. For example, one fragment was steel reinforced concrete 16 feet in length and 3 to 4 feet in width (Figure 6).

FIGURE 6. Large Fragment that Landed Between Magazines P-70 and P-71.

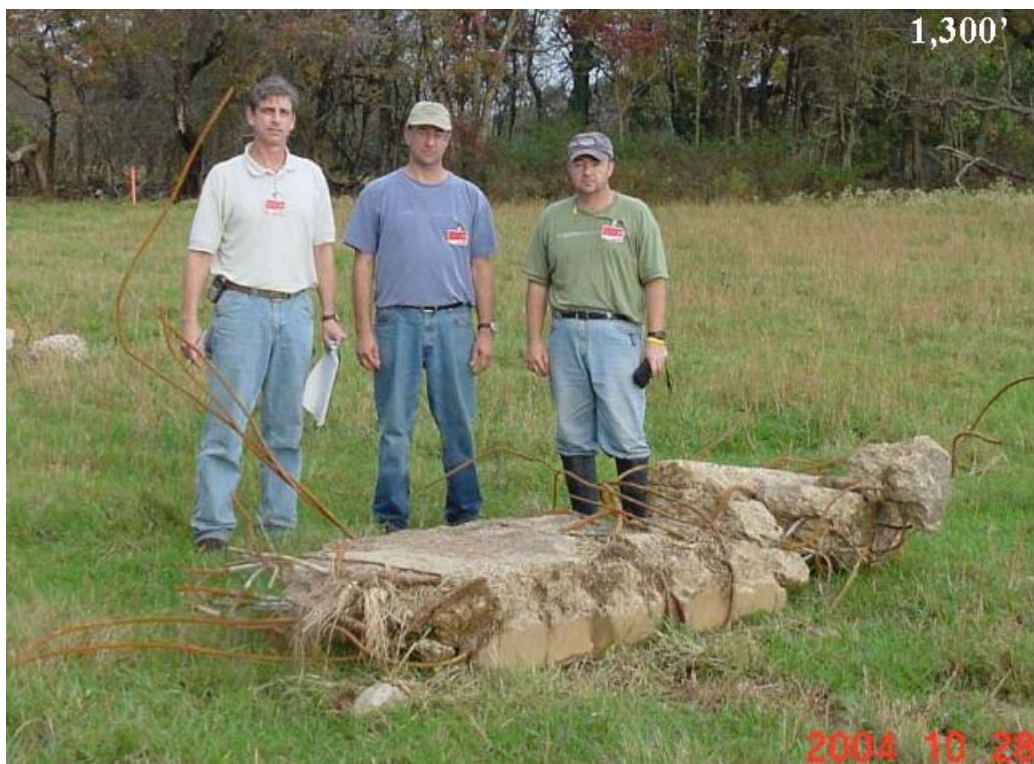
FIGURE 7. Large Fragment that had Been Part of the Headwall Found at Approximately 1,300 Feet from the Magazine.

The large fragment shown above traveled beyond the 1,250 foot radius for inhabited building distance (IBD) arc. Other large fragments were found significantly further than the 1,250 foot IBD arc. For example, there was significant damage to a tree located 2,100 feet in front of the magazine caused by a large fragment impact. Other debris estimated to have been a 6- by 8-foot section from the head wall significantly damaged a tree 3,100 feet from the magazine.

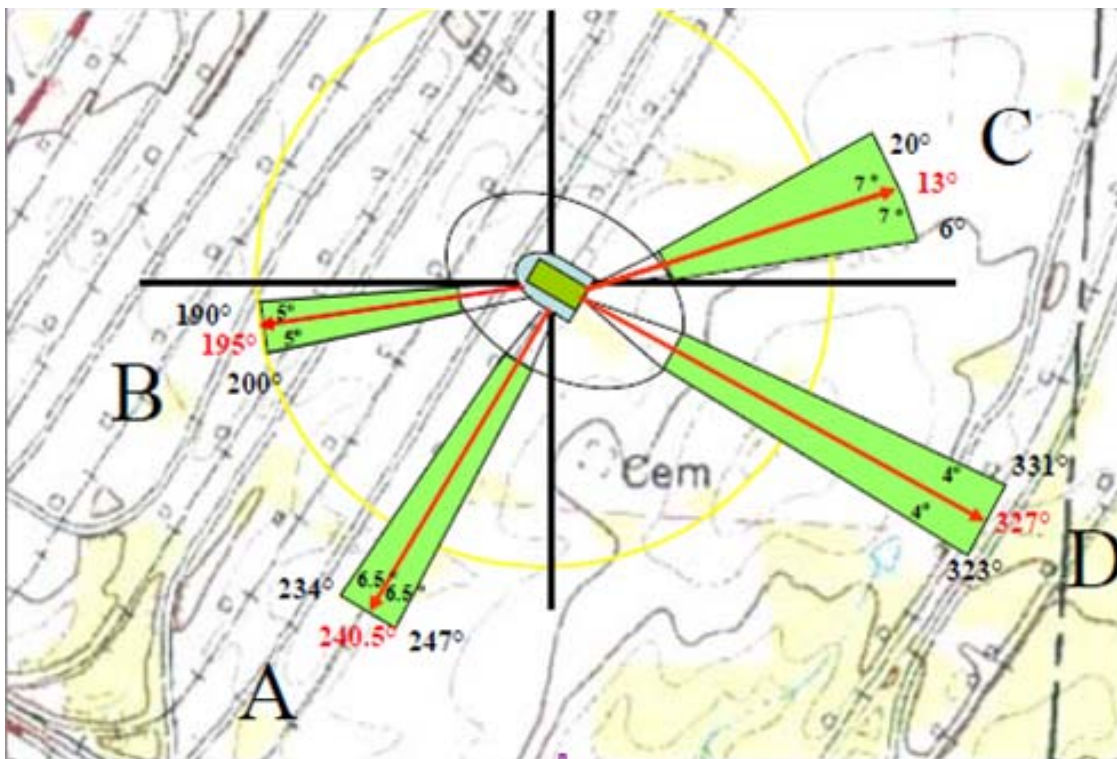
FIGURE 8. Search Sectors, Milan Accident 2004.

- Sector A. For the unit count method, there is a problem (more than one hazardous fragment/600 ft²) from 1,250 to 1,300 foot radius, and no problem out to 1,750 feet. However, for the weight-based count, there is a problem from 1,250 to 1,350 feet and again at about 1,550 feet.
- Sector B. There are essentially no problems for either the unit- or weight-based count from 1,250 to 2,400 feet radius.

- The use of unit count indicates excessive hazardous fragment density beyond the 1,250 IBD arc in one sector (A).
- The use of weight-equivalent count indicates excessive hazardous fragment density beyond the 1,250 IBD arc in three sectors (A, C, and D).

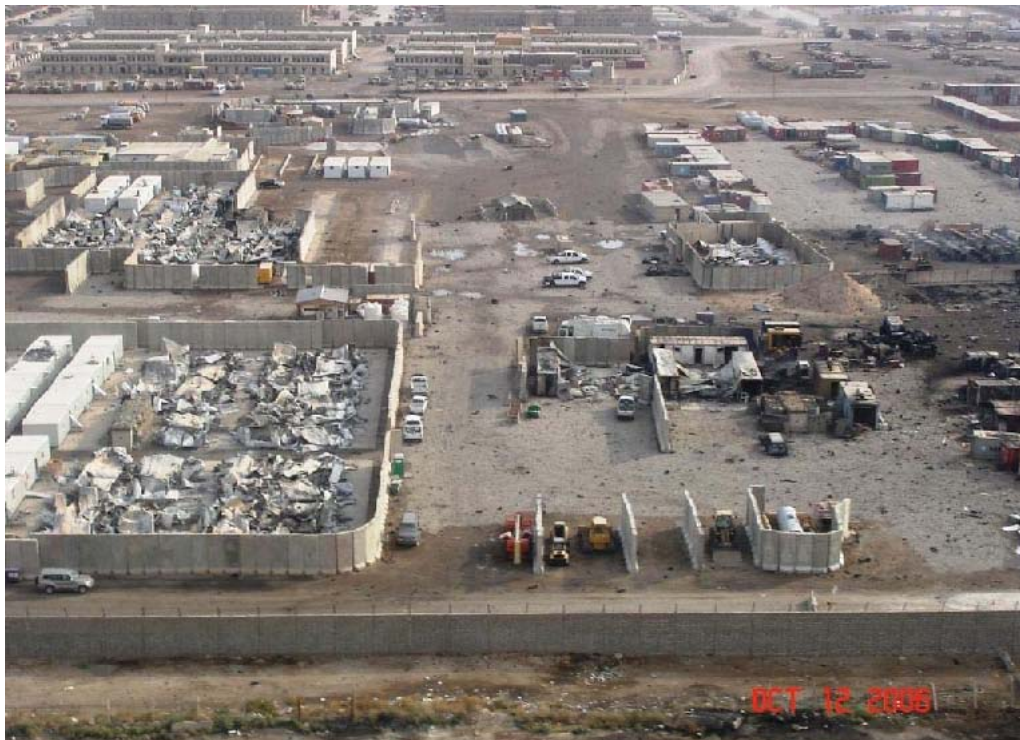
FIGURE 10. Damage at FOB Falcon near Baghdad, Iraq, 10 October 2006.

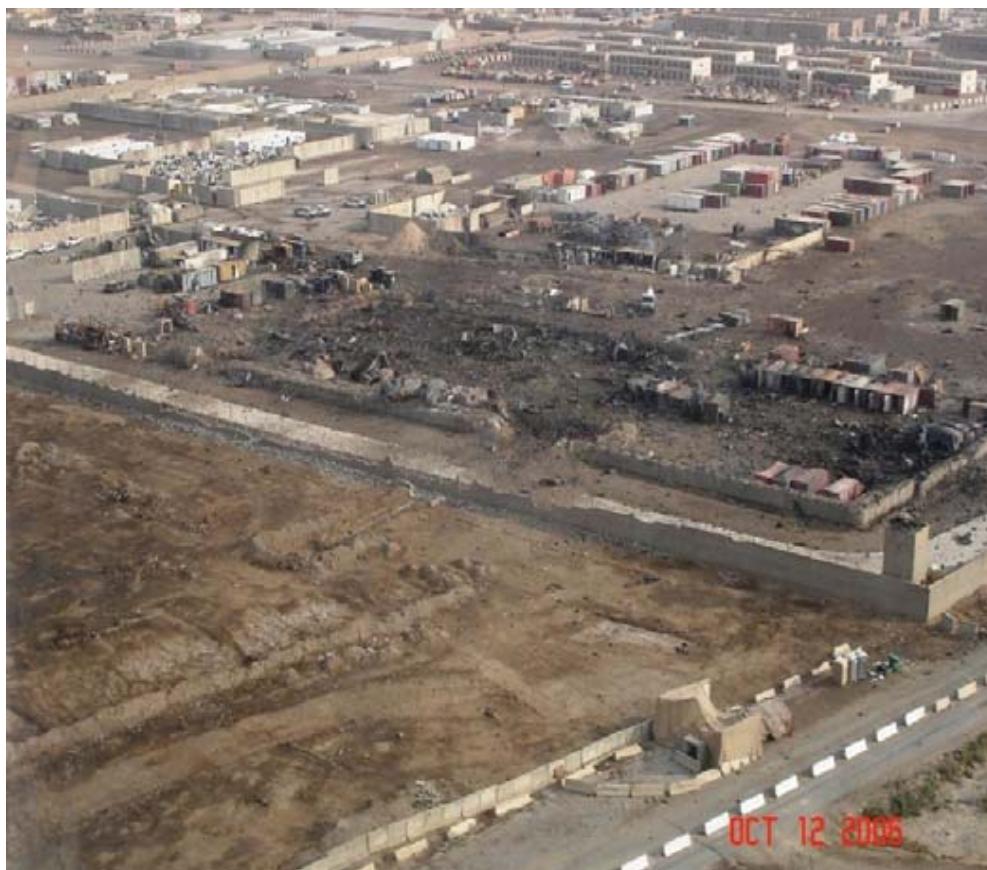
FIGURE 11. Damage at FOB Falcon near Baghdad, Iraq, 10 October 2006.

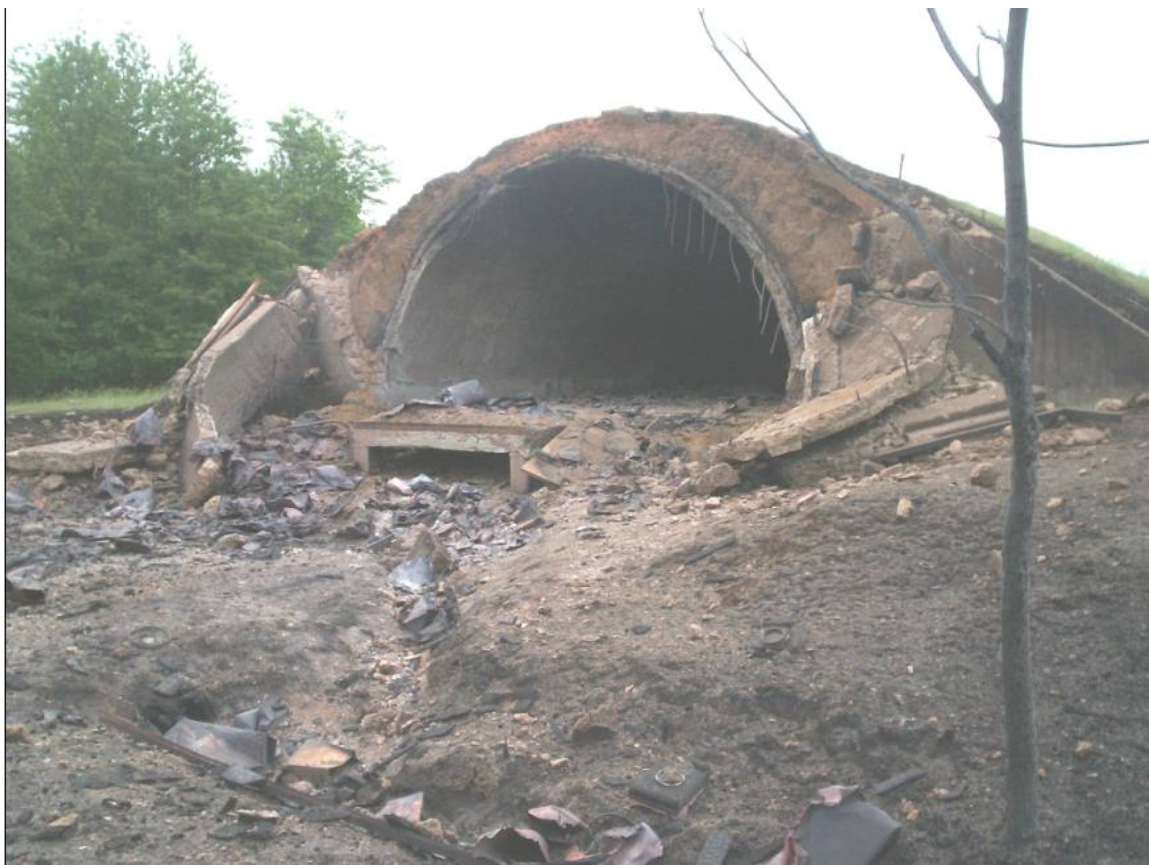
FIGURE 12. Earth-covered Magazine with Headwall Blown Out.

The cause of the accident was likely due to auto-ignition of the M-10 propellant as a result of stabilizer depletion.

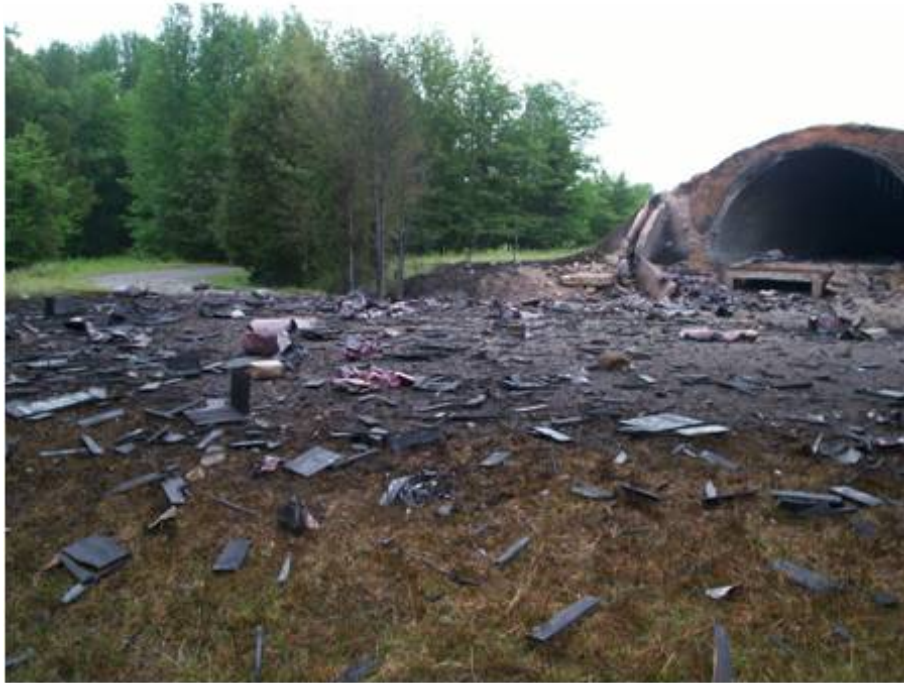
FIGURE 13. Debris from Magazine and Contents.

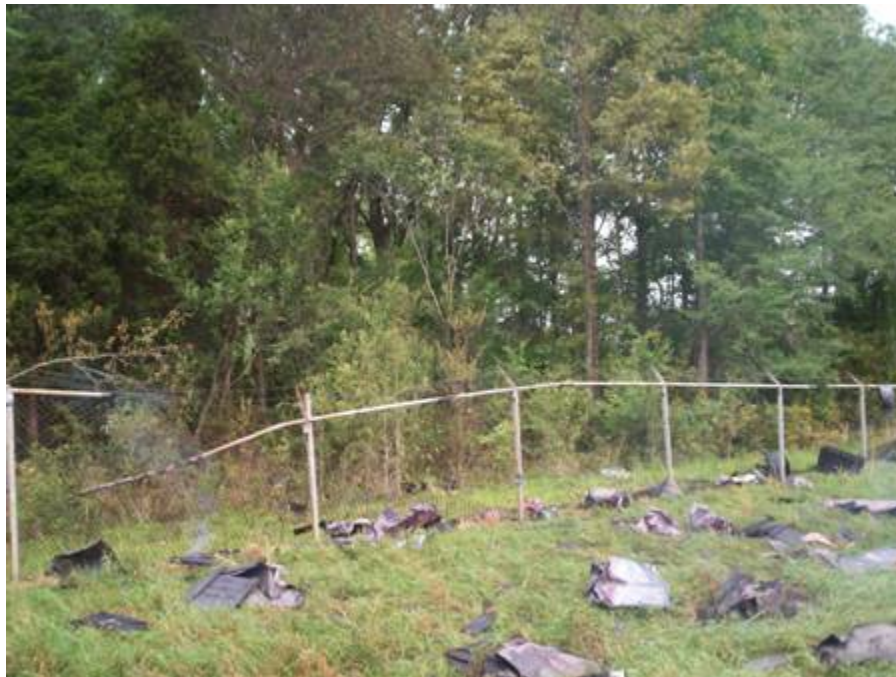
FIGURE 14. Debris Expelled from Magazine.

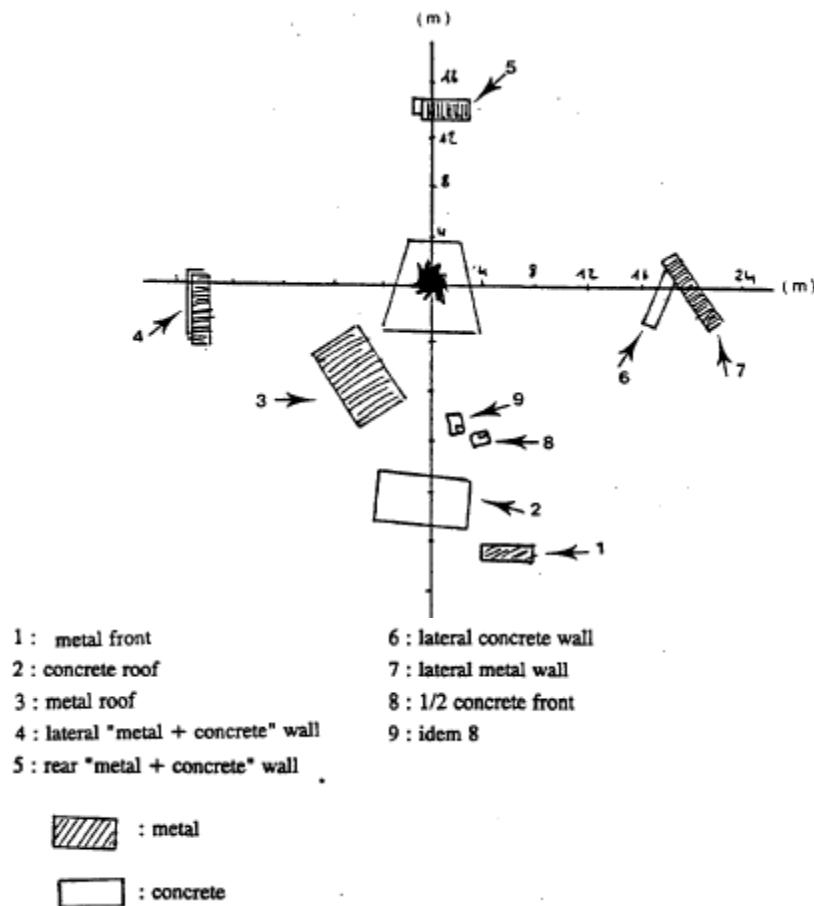
Test 4 resulted in the igloo bursting 1 second after ignition, releasing a fireball. At ground level, no trace of a plume was observed. The igloo separated along its structural lines or corners. It separated into five main parts, each comprising two pieces—one concrete and one steel as shown in Figure 21.

FIGURE 21. Location of Debris.

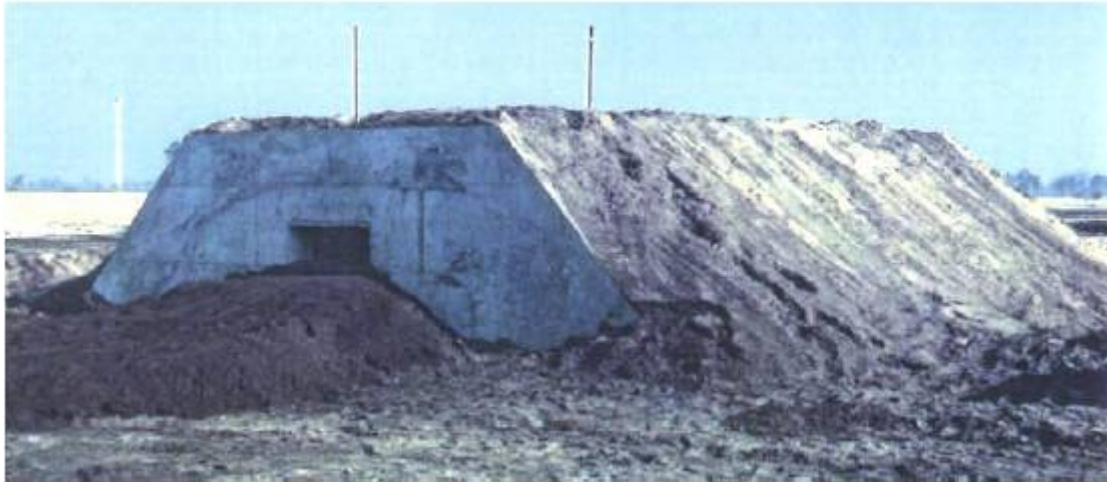
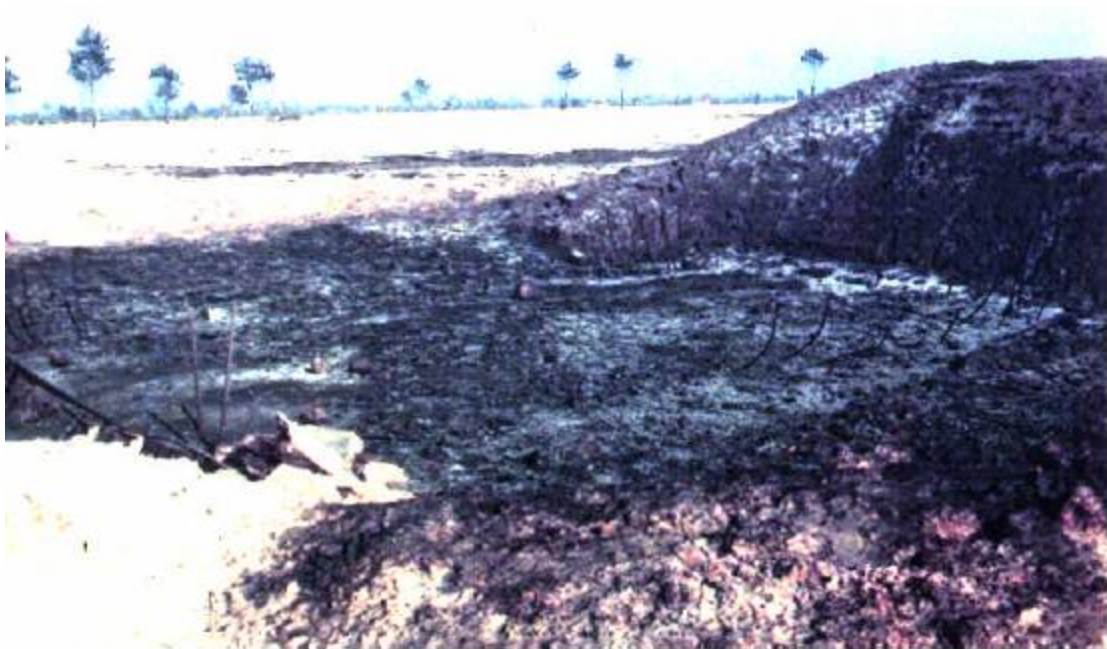
Interestingly, none of the overpressure gauges recorded any signal, nor was any crater formed, indicating neither a strong explosion nor a detonation occurred (Figure 22b). One of the internal overpressure gauges recorded an overpressure of 7 bars before saturating. The authors estimated that the maximum internal overpressure before rupture at 10 to 12 bars.

FIGURE 22. Captieux Trial Shot 4 (a) Before and (b) After.

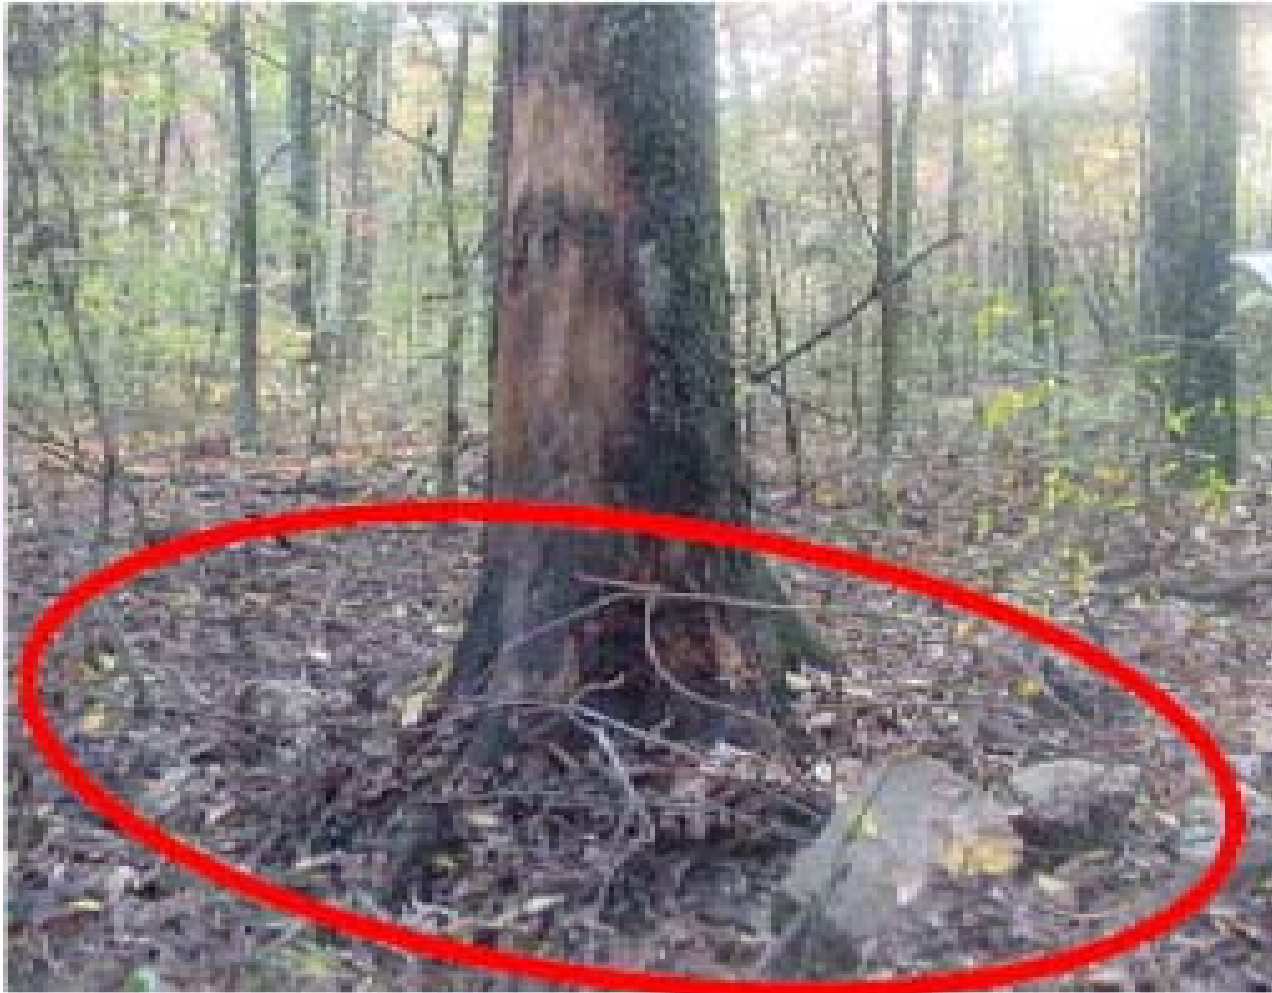
Milan 2004

Tree at 3100' from magazine impacted by 6' x 8' piece of headwall that shattered on impact with tree

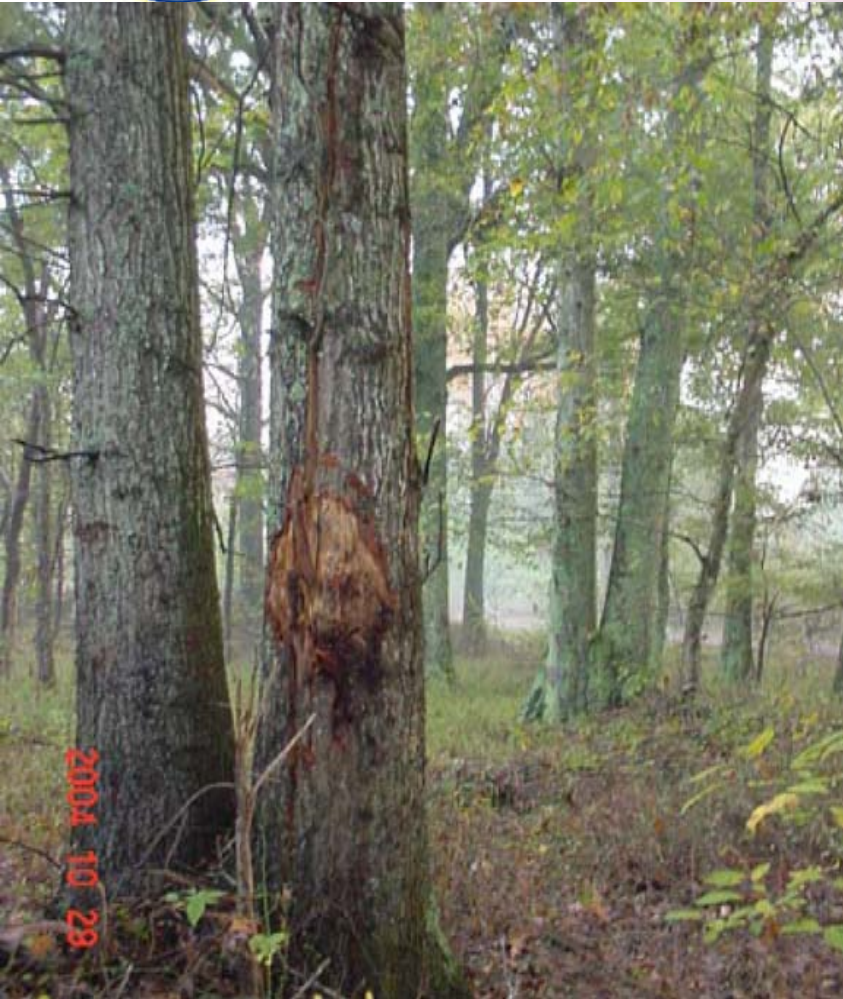
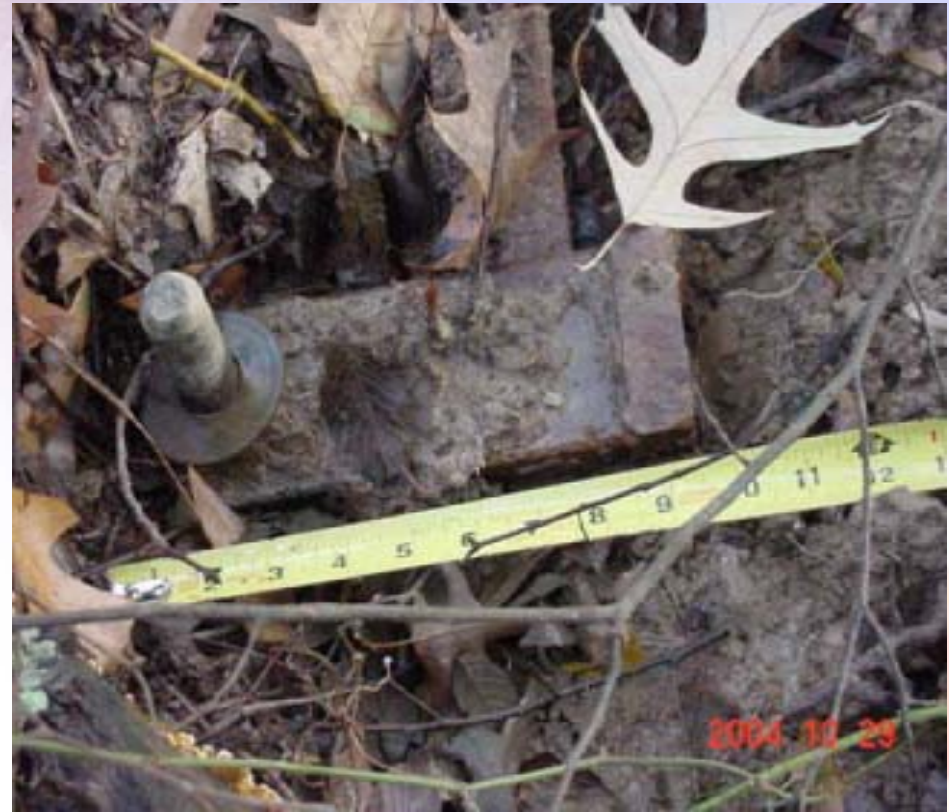
Milan 2004

Tree at 2100' impacted by large piece of headwall. Piece of hinge found at base of tree. Rebar and angle iron also found at base of tree. Concrete shattered on impact, concrete debris found beyond tree.

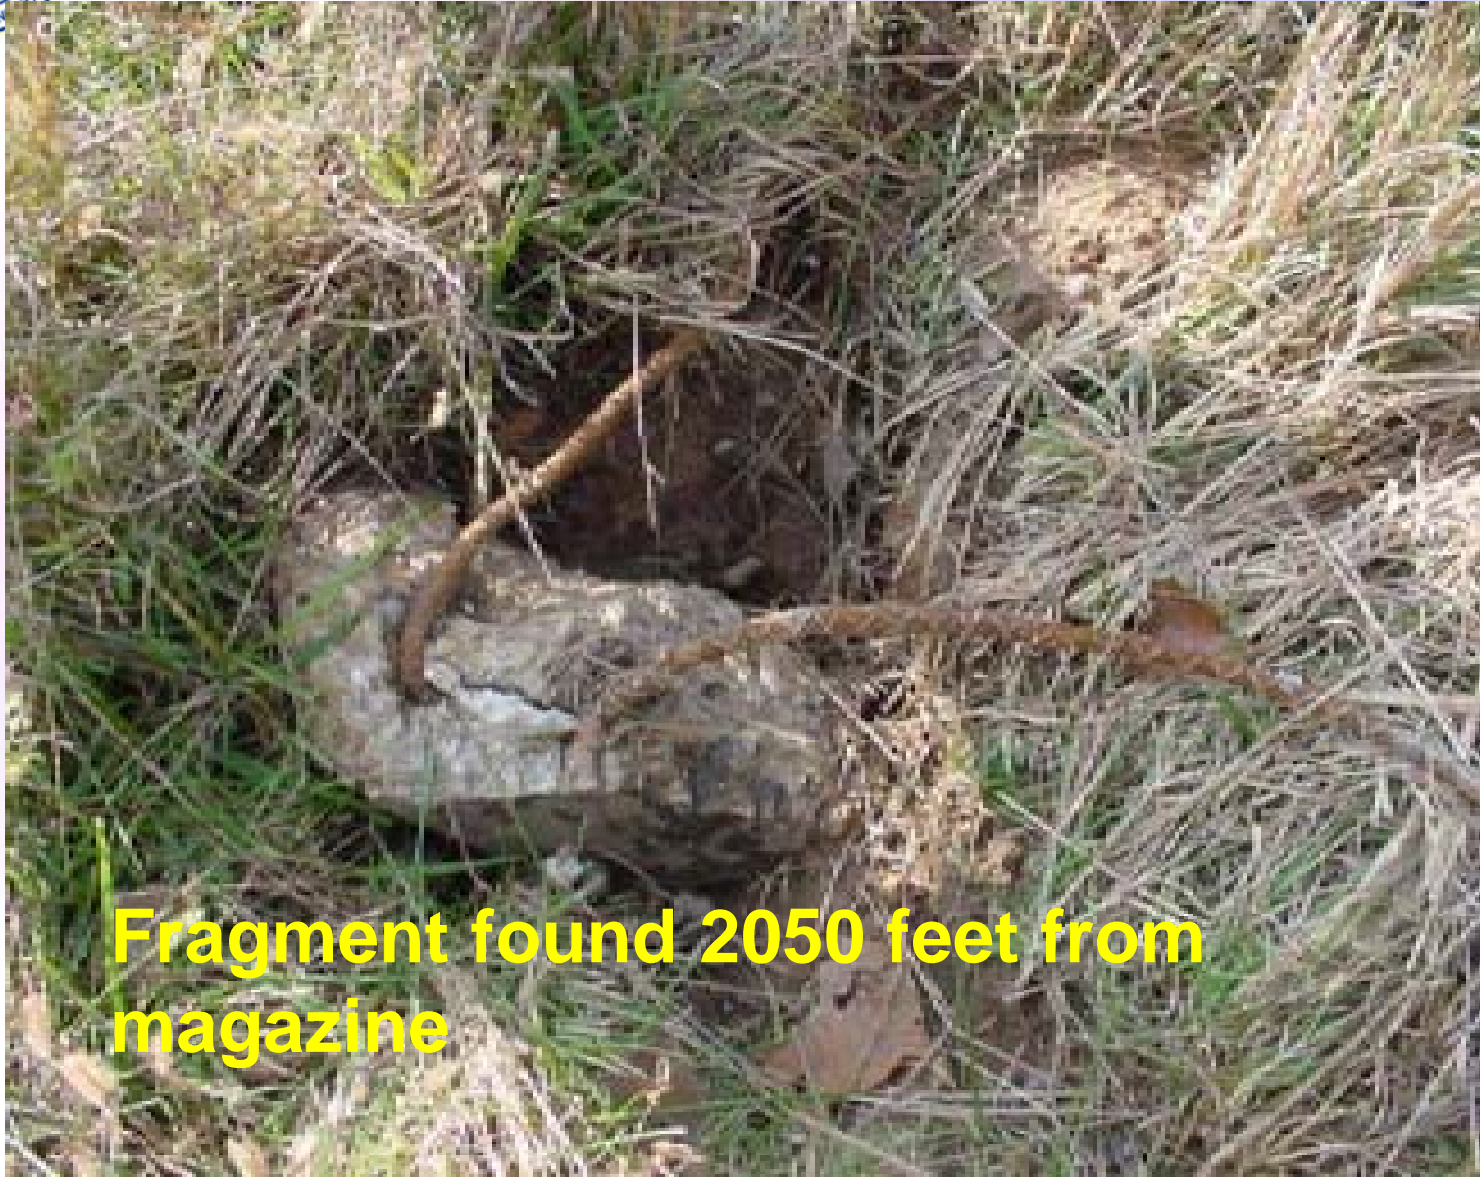
Milan 2004

Fragment found 2050 feet from magazine
